# VCERTT

## VERMONT CENTER For EMISSIONS REPAIR & TECHNICIAN TRAINING

# The Elusive EGR, P0400

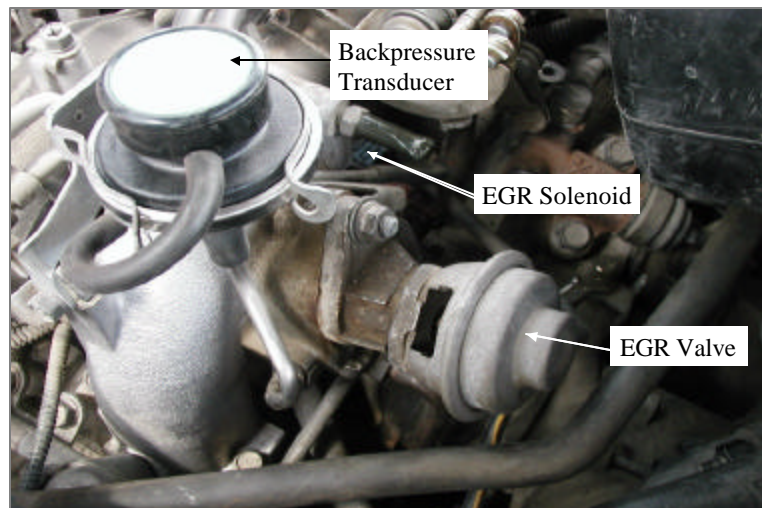
### 1997 Subaru Legacy 2.5L

This Fall we tackled another problem vehicle, a '97 Subaru Legacy with a repeated customer concern. This story starts early in the year 2000 when the MIL came on and the owner took the vehicle to an independent repair facility, which we'll call Shop #1. No drivability issues were reported at the time. Shop #1 extracted the DTC P0400, EGR Flow Malfunction. The shop ordered an EGR backpressure transducer, cleared the code and returned the vehicle to the customer. On the way home, the MIL came back on. Once the part arrived, the customer returned to Shop #1 to have the backpressure transducer installed. After the part was installed, the code was cleared and the vehicle returned to the customer. The MIL came back on again on the way home from the shop. The customer took the vehicle back to Shop #1; they inspected the system and informed the customer they couldn't find the problem. The vehicle then went to a Subaru Dealership, we'll call Shop #2. The customer encouraged them to call Shop #1 to find out what work had been performed, but unfortunately that didn't happen. Shop #2 installed a new backpressure transducer, cleared the code, and returned the vehicle to the owner. The MIL came back on shortly after picking up the car. The customer made another appointment with Shop #2. At this visit they replaced the EGR valve with a used one, cleared the code, and returned the vehicle to the customer. Again, the MIL came back on soon after picking up the car. The customer then brought the vehicle back to Shop #1. This time Shop #1 cleaned the EGR valve and the tubing to be sure it wasn't partially blocked and limiting flow. They confidently cleared the code and returned the vehicle to the customer. The MIL was back on not long after the vehicle was picked up. The customer next brought the vehicle to a different Subaru Dealer, we'll call Shop #3. Although encouraged to do

so, Shop #3 did not contact the other repair facilities about the previous repair attempts. They inspected the system, ordered a backpressure transducer and returned the vehicle. The customer returned to Shop #3 and had the third new backpressure transducer installed. The code was cleared, the customer picked up the vehicle, and, you guessed it - the MIL came back on shortly after the attempted repair. At this point, after eight trips to three different repair shops, three new backpressure transducers and a replaced EGR valve, and the MIL still on, the understandably frustrated vehicle owner contacted VCERTT.

We began our diagnosis by verifying that the MIL was on. We connected an OBDII generic scan tool and found DTC P0400, EGR Flow Malfunction present. The Freeze Frame data, stored when the code was set and the MIL turned on, showed: Engine RPM was 2,288, Engine Coolant Temperature was 183°F, Manifold Absolute Pressure was 15.4 inches hg., Vehicle Speed was 52 mph, Engine Load was 18.8%, and the Fuel System was in Closed Loop. This indicated that the problem was detected as soon as the OBD system ran the EGR monitor. Next, we performed a thorough visual inspection and checked the vacuum routing of the system. The vacuum lines appeared to be in good shape and they were all connected appropriately. There were no Technical Service Bulletins relating to this concern. We began testing the system by trying to get the EGR valve to operate by warming up the vehicle and raising the rpm while watching for EGR valve movement. The EGR valve never moved. We then applied vacuum directly to the EGR valve while the vehicle was running. We

could see the EGR valve pintle move and the vehicle began to stumble, as it should with EGR applied at idle. That proved that the EGR valve was OK and that the exhaust gas passages weren't blocked. Next we tested the backpressure transducer. Backpressure transducers can have a high failure rate. The transducer was receiving plenty of pressure from the exhaust gas pressure port on the bottom. It was also receiving a healthy dose of ported vacuum from the throttle body; vacuum was barely noticeable at idle and increased steadily as the throttle was opened (remember, this is ported vacuum, not intake vacuum).

Vacuum out of the transducer to the solenoid valve was also appropriate; there was no vacuum output at idle, a moderate vacuum was felt with moderate throttle, and when we heavily revved the engine strong vacuum was felt. Finally we tested the EGR solenoid valve. First we back probed the wires to look for power and ground supply. Power is supplied all the time. To complete the circuit, ground is provided by the PCM whenever conditions are appropriate (e.g., the vehicle is fully warmed up). We had power and ground supplied to the solenoid valve. We ran the engine at around 3000 rpm and checked to see if the solenoid valve was allowing vacuum through, and out to the EGR valve. We found that the solenoid valve was not allowing any vacuum to

the EGR valve despite the fact that it was electrically turned on. We then removed the solenoid valve for bench testing. That process was a bit awkward and probably explained the hesitation of other shops to test the last component in the system. We tested the resistance of the solenoid and found 33 ohms, well within specs. Finally, we applied 12 volts and ground to the solenoid valve. We didn't hear or feel the expected click, and we could not blow air through it. The solenoid valve did not open as it should have. Remember that a solenoid valve is an electro-mechanical device. Electrically, this solenoid valve was OK, but mechanically, it had failed. At this point we were fairly certain that we had found the culprit. Given all the misery the customer had endured we went ahead and sourced a new EGR solenoid valve (a \$60 part) and bench tested it. We heard that familiar click as we applied power and ground, and could easily blow air through it. We installed the new solenoid valve, reassembled the vehicle, and checked for proper operation. Sure enough, once the vehicle had warmed up again, we revved the engine and watched the EGR valve pintle move. To fully verify our repair we cleared the code and road tested the vehicle. We brought the vehicle back in and checked the Readiness Status of the EGR Monitor. The monitor was completed: the test had run and passed; our repair was successful. Several months and several thousand miles later, the vehicle owner happily reports that the MIL has not come back on.

- ✍️ Quick and simple testing of the EGR valve and back pressure transducer would have shown those parts to be OK. That left only one more component – the solenoid valve. None of the repair shops checked out the solenoid valve.
- ✍️ Remember that a solenoid valve is an electro-mechanical device. To operate properly, both the electrical and the mechanical functions have to work.
- ✍️ No matter how many times a part is replaced, if it's not the right part, it won't fix the problem!
