# VCERTT NEWS

WINTER, 2006

## VCERTT CASE STUDY

### 1997 OLDSMOBILE CUTLASS: P0171

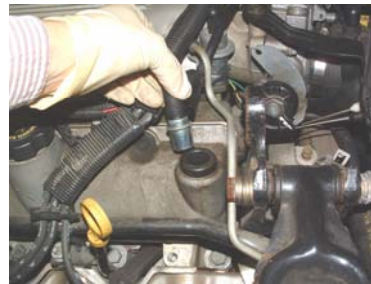
Next we had to eliminate all the possible causes of a lean condition or excess oxygen in the exhaust. A misfire will cause excess oxygen in the exhaust, even though the fuel mixture is not necessarily lean. If the mixture does not burn fully the remaining oxygen in the combustion chamber passes by the O<sub>2</sub>S causing a low voltage reading. This vehicle did not appear to be misfiring under any conditions. Other likely causes of a lean condition include problems with the fuel system such as a plugged fuel filter, dirty injectors, a weak fuel pump or a faulty fuel pressure regulator. Sensors can also cause lean running. A mass airflow sensor (MAF) that is not reporting all the air passing by will cause the PCM to deliver less fuel. This is currently a common problem. We did clean the MAF but saw no changes in the readings. The ECT sensor or IAT sensor could also skew the fuel delivery but they were fine. Before digging deep into the fuel system we followed a hunch and looked at the slightly noisy, shiny PCV valve. It looked and rattled fine but it had a slight whistle. When we

blocked off the vacuum side, the fuel trim began to drop, reaching very close to 0%. We would expect it to drop some, but thought that a full drop to 0% pointed to a problem. The part number was not applicable to this vehicle. With the correct PCV valve (lower flow) the

fuel trim dropped and the O<sub>2</sub>S started cycling regularly between .1 and .9 volts. We had the luxury of driving the vehicle for a while to see if the PCM would extinguish the MIL on its own. It took several drives and an overnight cool down but the OBD system did recognize the correction and the PCM turned the MIL off. For more information on oxygen sensor and fuel trim diagnosis, watch for our revised Oxygen Sensor and Air Fuel Ratio Sensor Diagnosis course and our new course, Fuel Trim DTCs and Diagnosis.
