VCERTT NEWS

VCERTT: VERMONT CENTER FOR EMISSIONS
REPAIR AND TECHNICIAN TRAINING
A PARTNERSHIP OF VERMONT TECHNICAL
COLLEGE AND THE VT DEPARTMENT OF
ENVIRONMENTAL CONSERVATION TO
PROVIDE OBDII INFORMATION AND
TRAINING TO VERMONT TECHNICIANS

FALL, 2004

VOLUME 3, ISSUE 2

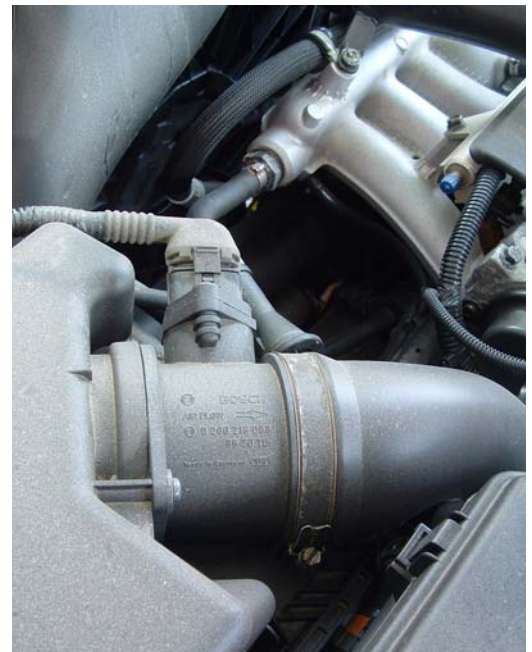
The fault with the sensor appears to be contamination of the sensor's hot wire. The sensor wire is heated to a particular temperature. Air passing across the sensing wire cools it. The sensor increases the current to maintain a constant wire temperature. The more airflow across the wire the greater the

current required to maintain the wire temperature. This varying current is converted to a variable frequency that the PCM uses to infer intake airflow. When the wire becomes contaminated, the airflow across it does not cool it as it should. The current is not increased as much and the PCM "sees" less airflow than is actually occurring. This results in a lean air/fuel mixture.

In order to diagnose the sensor, some suggest cleaning the hot wire with Brake Kleen or electric cleaner. Lint from low quality air filters is a very common culprit. Excessive oil on a K and N air filter will also contaminate

the hot wire and limit its sensitivity. Some technicians are carefully pulling lint off of the sensing wire with tweezers. After cleaning the wire, drive the vehicle to see if the symptoms have lessened. If so, the sensor is the faulty component. Some technicians are cleaning the sensors without replacing them though most are following the manufacturers suggestion and replacing the sensors.

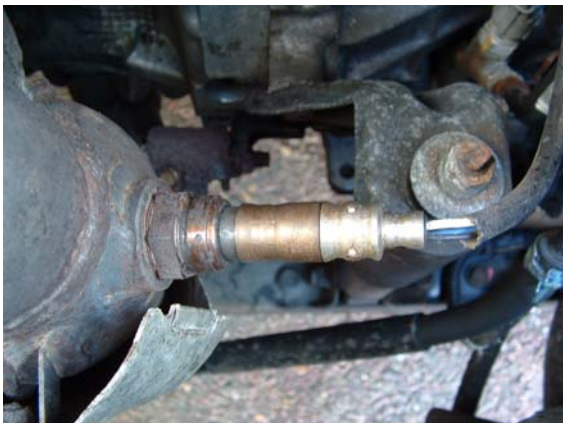
With gas prices as high as they are, you may be able to save your customers some money by replacing the oxygen sensor (O2S). An O2S with over 100,000 miles may well deserve to be changed; evidence shows that fuel economy increases with new oxygen sensors. It is not uncommon to gain 4-5 mpg after replacing a faulty O2S. With today's gas prices that means that a \$100 O2S on a vehicle that went from 25 to 30 mpg would be paid for in about 7,000 miles. Most OBDII vehicles will do a pretty good job at identifying a faulty oxygen sensor. If you get a vehicle into your shop with the MIL on and an O2S DTC, visually inspect the wiring and test the heater circuit to be sure it is functional. Most vehicles will show voltage across the heater wires with the key on but a few require that the vehicle be running. Many manufacturers activate the heater using a steady 12 volt supply; others use a duty cycle signal to control the current flow. If you find a heater circuit with less than 12 volts and the wiring is good you are probably testing a duty cycle controlled O2S. Any voltage between 1 and 12 volts indicates that the circuit is functional. Many Bosch O2S (there are a lot out there!) use white wires on the O2S as the heater wires as shown in the figure below. One other thing to

check is the heater element resistance. Put your digital multimeter probes across the two heater terminals on the O2S and check that you have continuity. Resistance values will vary with temperature. If you have an open, you have found a faulty O2S. If the heater circuit checks out OK, you can be pretty confident that the powertrain control module (PCM) has correctly identified a faulty O2S. If the PCM sees either a too lean or too rich condition it will usually set a fuel trim DTC, not an O2S DTC. To confirm the PCM's diagnosis, check the O2S signal with a scan tool, voltmeter, or scope. The scan tool may be inconclusive if the sensor is still functional; the sampling rate is so slow it is difficult to pick up the signal trend. You may well see a .2 and .8 volt signal but you may not be able to tell that the sensor is biased either rich or lean. A digital mul-

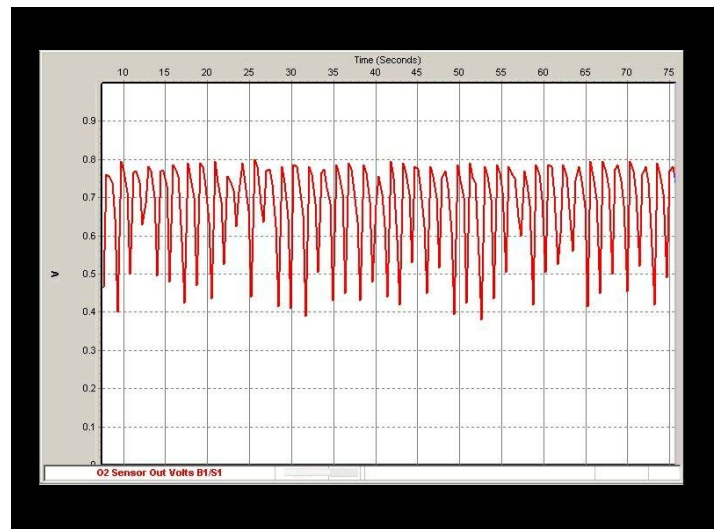
SIGNAL FROM FAULTY O2S

The best way to view an O2S signal is with a scope. We recently worked on a 1995 OBDII Toyota Tacoma 2.7L, 5-speed, 4WD with about 114,000 miles on it. The MIL was on and DTCs P0130 (O2S circuit malfunction), and P0133 (O2S circuit slow response), were present. The wiring to the sensor looked good and the heater had 12 volts and ground with the key on. The following figure shows the O2S signal with the old sensor installed.

The sensor was biased rich, cycling between .4 and .8 volts. We also performed emissions testing on the dynamometer and calculated fuel economy. The hydrocarbons (HC) and carbon monoxide (CO) were quite low but the oxides of nitrogen (NOx) were above the federal standard. The biased O2S had been causing the PCM to adjust fuel trim to be too lean. This lean, hot air/fuel mixture produced high NOx emissions.

We replaced the faulty O2S and retested the system. The new oxygen sensor was cycling regularly between .2 and .8 volts as shown in the figure on the next page.

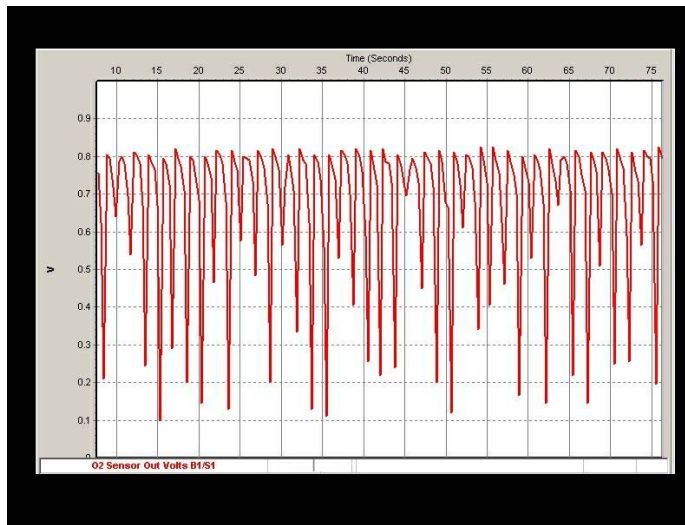
SIGNAL FROM NEW O2S

The NOx emissions went way down below the standard and the calculated fuel economy increased by 30%! The customer should make money on that repair. We will wait for an update from the customer about the actual fuel economy

gains. The new oxygen sensor fixed the vehicle, cleaned up the NOx emissions, and increased the fuel economy.

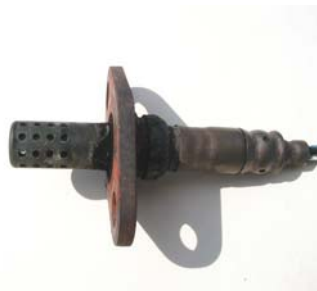
THE FAULTY OXYGEN SENSOR
