# VCERTT NEWS

WINTER, 2006

## VCERTT CASE STUDY

### 1997 OLDSMOBILE CUTLASS: P0171

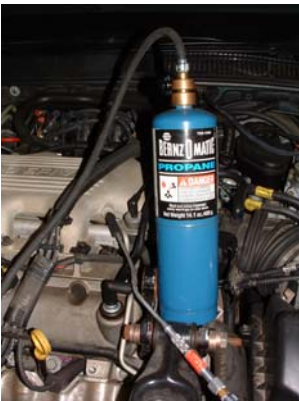
This fall we had the chance to work on a pesky Cutlass with a persistent DTC, P0171 System Too Lean, Bank 1. The vehicle came to us after a couple of repair attempts at another garage. The front oxygen sensor had been replaced along with the spark plugs, wires, and coil pack. We drove the vehicle and noted no unusual drivability concerns other than a slightly high idle. Our visual inspection showed nothing, though we looked and listened carefully for a vacuum leak. We used our new favorite tool, the smoke machine, to check for vacuum leaks. A vacuum leak is a common cause of lean Fuel Trim DTCs and with the high idle we were hopeful that we'd quickly find the problem. We found no leaks. If you don't have a smoke machine you can use propane to try to find a vacuum leak. When the propane is taken into the engine through the leak, the idle quality will change. We did bring out our propane next, in order to test the oxygen sensor. Even if it was new we wanted to be sure that it was working properly and that the PCM was receiving its signal. On a scan tool with the vehicle idling and at 2500 rpm it was clear that the oxygen sensor signal was staying at a lower voltage, .1 - .4V, indicating a lean condition to the PCM. If the system were working properly we would expect to see the oxygen sensor signal cycling regularly between 0 and 1 volt, (.1-.7-.3-.8-.4-.5-.2-.8, for example). The long term fuel trim (LTFT) was running between +19% and +26%. Long term fuel trim is displayed in percentages between -100% to +100%. A reading of 0% indicates that the PCM is making no correction to the preprogrammed fuel delivery value for the current operating conditions

based on the sensor inputs. The PCM changes fuel trim in response to the oxygen sensor (O<sub>2</sub>S) signal. If the O<sub>2</sub>S indicates a lean condition (low voltage) in the exhaust stream, the PCM responds by adding fuel by increasing the injector pulse width. It does this constantly through short term fuel trim (STFT). These are instantaneous changes made in direct response to the O<sub>2</sub>S. When the STFT increases enough, the PCM makes a fuel trim correction in long term fuel trim and resets the STFT to 0%. It will continue to adjust STFT then LTFT until it has control of the fuel system. When LTFT rises over or falls below a preprogrammed amount, typically plus or minus 20%, the PCM recognizes that there is a problem, sets a DTC and turns on the MIL. If the system is running too rich, the PCM subtracts fuel and the LTFT drops into the negative zone. For diagnosis the LTFT numbers are the ones to watch, these indicate the fuel trend not just the mixture at a particular instant.

On this vehicle, we needed to be certain that the oxygen sensor was capable of generating a higher voltage signal and that it was correctly reporting an excess of oxygen in the exhaust stream. We introduced propane into a vacuum port to richen the fuel mixture. We kept a close eye on the O<sub>2</sub>S reading on the scan tool to see how it responded before the PCM could compensate. Sure enough it shot right up to .9 volts and stayed there. The LTFT started dropping as we held the propane on and the idle began to smooth out. This proved that the sensor was at least active, and that the PCM saw the signal and could respond. Now we knew we were actually dealing with an excess of oxygen in the exhaust stream, likely a lean condition, not a faulty oxygen sensor.

Next we had to eliminate all the possible causes of a lean condition or excess oxygen in the exhaust. A misfire will cause excess oxygen in the exhaust, even though the fuel mixture is not necessarily lean. If the mixture does not burn fully the remaining oxygen in the combustion chamber passes by the O<sub>2</sub>S causing a low voltage reading. This vehicle did not appear to be misfiring under any conditions. Other likely causes of a lean condition include problems with the fuel system such as a plugged fuel filter, dirty injectors, a weak fuel pump or a faulty fuel pressure regulator. Sensors can also cause lean running. A mass airflow sensor (MAF) that is not reporting all the air passing by will cause the PCM to deliver less fuel. This is currently a common problem. We did clean the MAF but saw no changes in the readings. The ECT sensor or IAT sensor could also skew the fuel delivery but they were fine. Before digging deep into the fuel system we followed a hunch and looked at the slightly noisy, shiny PCV valve. It looked and rattled fine but it had a slight whistle. When we

blocked off the vacuum side, the fuel trim began to drop, reaching very close to 0%. We would expect it to drop some, but thought that a full drop to 0% pointed to a problem. The part number was not applicable to this vehicle. With the correct PCV valve (lower flow) the

fuel trim dropped and the O<sub>2</sub>S started cycling regularly between .1 and .9 volts. We had the luxury of driving the vehicle for a while to see if the PCM would extinguish the MIL on its own. It took several drives and an overnight cool down but the OBD system did recognize the correction and the PCM turned the MIL off. For more information on oxygen sensor and fuel trim diagnosis, watch for our revised Oxygen Sensor and Air Fuel Ratio Sensor Diagnosis course and our new course, Fuel Trim DTCs and Diagnosis.
