VCERTT NEWS

VCERTT: VERMONT CENTER FOR EMISSIONS
REPAIR AND TECHNICIAN TRAINING
A PARTNERSHIP OF VERMONT TECHNICAL
COLLEGE AND THE VT DEPARTMENT OF
ENVIRONMENTAL CONSERVATION TO
PROVIDE OBDII INFORMATION AND
TRAINING TO VERMONT TECHNICIANS

FALL, 2005

VOLUME 4, ISSUE 2

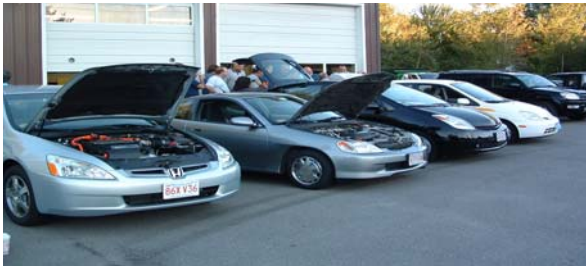
There are almost 1,300 hybrid vehicles registered in VT as of 8/05. That is nearly double the number registered at the same time last year. Toyota, Honda, Ford, Lexus all have some form of hybrid this year and the numbers are increasing rapidly. Honda says that 50% of their fleet will be offered in a hybrid option by 2007!

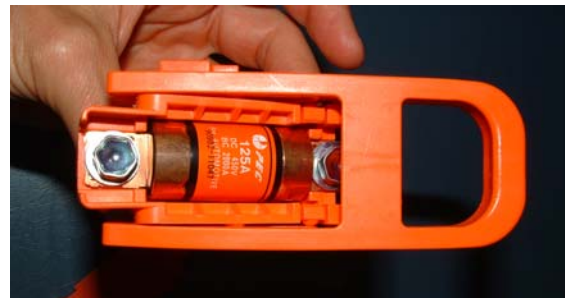
The bottom line about hybrid service is: do not touch the orange wires without lineman's gloves on (available at www.grainger.com for under \$30) and turn the high voltage system off before servicing the vehicle. In most cases, disabling the high voltage system is a very simple task. One example includes removing the key and waiting 5 minutes for the capacitors to discharge. As a secondary prevention, manufacturers may ask you to disconnect the 12 volt battery, remove a service plug, or turn the high voltage switch to off. The service plug on the Toyota Prius is located in the left front corner of the trunk. It is bright orange, shown below, and is removed. Honda has an orange cover under

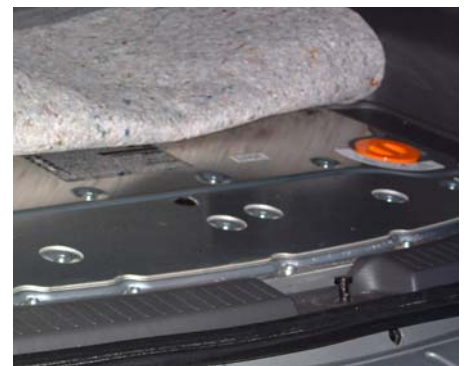
the carpet on the right side of the trunk, shown below. Simply remove the cover and turn the traditional household

type switch to off. Again, these are typical and basic procedures required to isolate the high voltage system from the rest of the powertrain and chassis. This does not mean you can take your common digital multimeter and start probing orange wires. We will cover some of those specific procedures on the more common hybrids in upcoming newsletters. Stay tuned for upcoming trainings and articles on hybrids.
